Sand Island Lighthouse

Restoration Plan

Sand Island Lighthouse Restoration Plan

September 2007

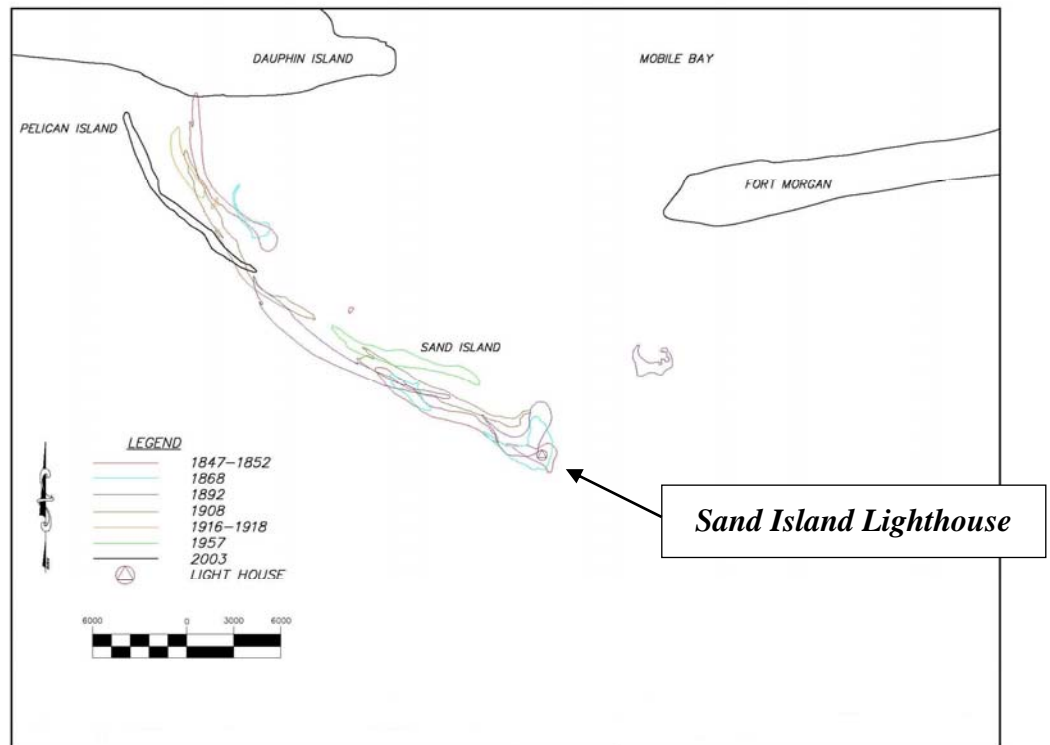
Historic Changes in Sand Island Shoreline Since 1847

Sand Island is part of the outer bar located at the mouth of Mobile Bay in the open waters of the Gulf of Mexico. Comprised entirely of unconsolidated sands, the island is highly unstable, with its shoreline being continually reconfigured by the effects of tidal flows, littoral drift, and the forces of tropical storms. Examination of historic maps and coastal surveys document the history of continual change that has always characterized Sand Island's shoreline. Sand Island has continued to migrate to the west, leaving the Lighthouse in the open waters of the Gulf of Mexico. As the island sands have moved westward, only the existing blanket of rocks remains to protect the Lighthouse's foundation from being undermined.

Bottom depths in the vicinity of the lighthouse generally range around 20 feet. However, four scour holes occur in the bottom near the lighthouse island exceeding 45 feet in depth, with one exceeding 55 feet. The holes are close enough to the toe of the lighthouse island that they may have the potential to undermine the rock blanket covering the island and the underlying sand within which the foundation of the lighthouse is embedded. This could result in the catastrophic failure of the tower.

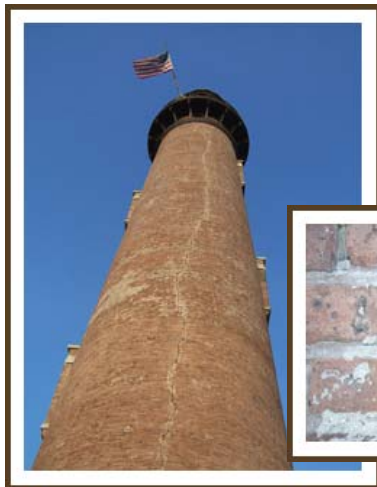
The lighthouse has two distinct vertical cracks (one on the east side and one on the west side) that extend for much of the height of the tower and completely through the wall from the exterior to the interior. The width of these major cracks averages about 3/8 to 1/2 inch, with the maximum width measured at 1 inch. There are also smaller, tighter vertical cracks on the

*External Vertical
Cracking on East Side of
Lighthouse*

Extreme rusting (and swelling) of the embedded I-beams that support the stair landings caused the masonry to crack and form the continuous vertical cracks on the east and west sides of the lighthouse described above.

- Repair the vertical cracks and add anchored stainless steel tension rings within the interior of the lighthouse to bind the tower together and restore its integrity as a solid unit. Also, embed stainless steel ties across the cracks during masonry repairs to give additional strength to the mortar.
- A critical feature of any restoration plan will be the inclusion of measures to protect and enhance the integrity of the island upon which the lighthouse foundation is embedded.

- Seal vertical cracks by injecting a hydraulic lime slurry grout to tie and seal off all breaks in the masonry from the exterior surface through to the interior wall. Embed stainless steel ties across cracks and replace broken and missing bricks.
- Install 16 tension rings within the interior wall of the tower – a set of two rings below and above each of the eight stair landings. The purpose of the tension rings would be to stabilize the lighthouse by tying together the vertical tower segments that have been separated by the existing cracks. The tension rings would be made of high

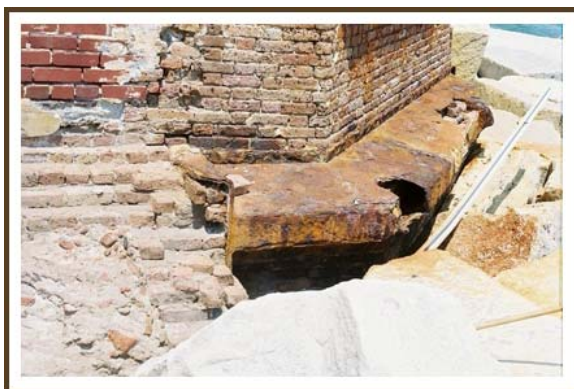
*Damage to Cast Iron Ring on West
Side of the Base of the Lighthouse*

The lighthouse base (i.e., plinth) has upper (i.e. cornice) and lower (i.e. base) rings of cast iron. The cast iron rings are badly deteriorated from rust and severe pounding from rock boulders that have been moved during the many storms to which the lighthouse has been exposed over the years.

The metal rings forming the cornice and surrounding the base of the lighthouse have also experienced considerable corrosion over the years, with the base ring being severely damaged by the pounding of wave-driven rock boulders during major storm events.

- The restoration plan for the lighthouse should include repair of the damages to the plinth: (1) replace damaged bricks; (2) repoint eroded mortar; and (3) replace the cast iron rings with a suitable metal that would be more resistant to corrosion and capable of withstanding the pounding from wave driven boulders to which it would be exposed periodically.

- Repair the cast iron ring protecting the base of the plinth section. This cast iron ring and the underlying bricks have been extensively damaged as a result of corrosion and the pounding the lowest portion of the lighthouse experiences from waves and wave-driven boulders that crash against the lighthouse during storm events. The base would be repaired by constructing a new reinforced concrete ring that would be placed on top of and envelop the existing base. Steel dowels would be drilled into the base bricks and attached to steel reinforcing bars that would be curved around the base and embedded within the concrete. The concrete would be colored to create the illusion of corroded metal to match the cornice cast iron ring. Construction of the reinforced concrete ring could be accomplished without having to disturb any of the existing protective rocks surrounding the lighthouse base. This approach would reduce the risks to the lighthouse during construction, while providing a stronger ring around the base of the lighthouse in a cost-efficient manner. The Alabama State Historic Preservation Officer supports this approach. (Note: Installation of the reinforced concrete ring and repair of the underlying damaged masonry will be accomplished during 2008 with a grant provided by the Federal Emergency Management Agency to repair damages attributed to Hurricane Ivan.)

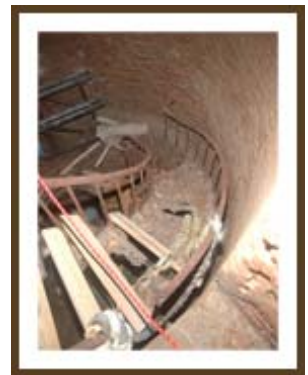
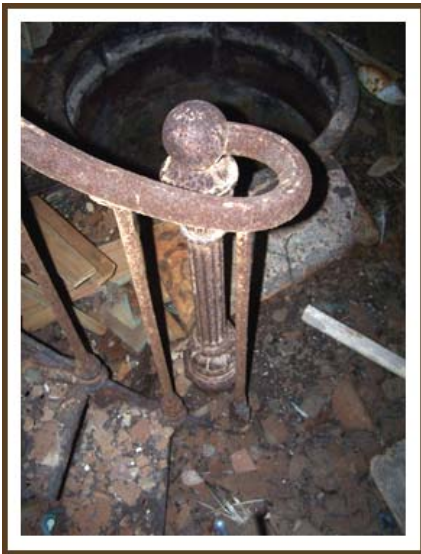
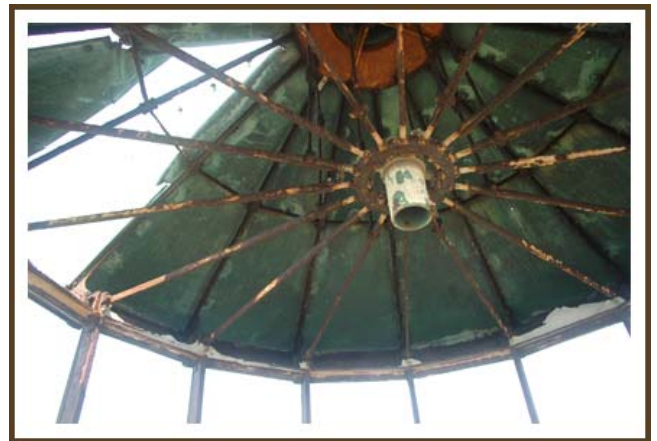
The eight flights of internal stairs, rails and landings have all experienced considerable corrosion over the life of the lighthouse, as has the lantern room and exterior platform and associated handrail surrounding the outside of the lantern room. The structural integrity of these metal features has been weakened to the point that they are unreliable for restoration. The stairs, handrails, and landings and associated hangar rods and platform brackets and all metal associated with the lantern room need to be repaired or replaced if safe access is to be provided to the top of the lighthouse.

Although the copper roof is basically intact, two panels have been bent out of place, but still remain attached to the roof.

Representative views of corroded and damaged iron in stairs, landings, platforms, handrails, and damaged roof panels.

- The internal stair system, landings, lantern room, and the platform and handrails surrounding the exterior of the lighthouse must be replaced in their entirety or repairs undertaken to make them safe. The roof should be repaired by a qualified coppersmith. The repair should consist of bending the two panels back in place and soldering clips on the underside of the panels. Similarly, small patches could be soldered over the torn section of copper panel. All metal should receive a protective coating to resist corrosion.

- Reattach loose copper roof panels.
- Stabilize the lowest window on the north side of the lighthouse that is presently used to gain access to the inside of the lighthouse. This window is in danger of falling out of the tower and needs resetting with lime mortar.

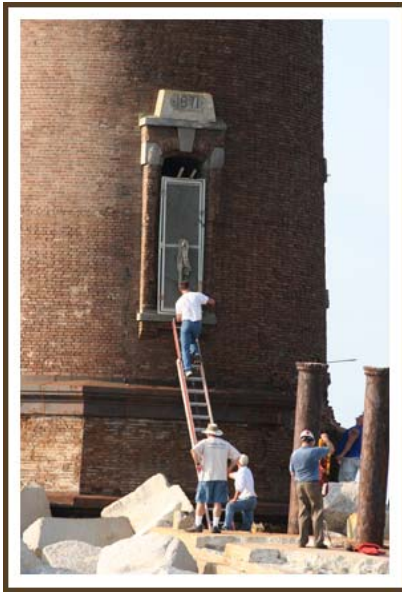
Lower window on north side of lighthouse used to access tower

With the closing of the door, the lowermost window on the north side of the tower was converted to the entry door used by the lighthouse keeper. The lowermost window still serves today as the access point into the tower.

All of the windows are made of wood casings and glass and are seated in an iron frame. The iron materials have corroded beyond repair, the wood has rotted, and the glass is missing from the windows.

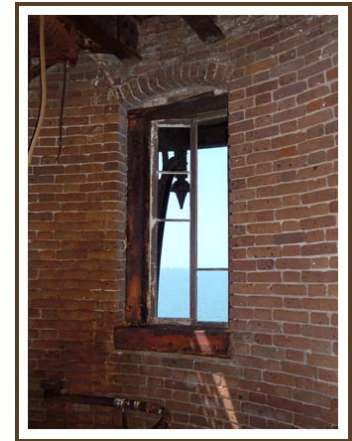
Interior view of one of the small windows near the top of the lighthouse

- A long-term restoration program should include measures to replace the windows and to provide a functioning door representative of the 1870s when the lighthouse was constructed.
