Sand Island Lighthouse

Restoration Plan

Sand Island Lighthouse Restoration Plan

September 2007

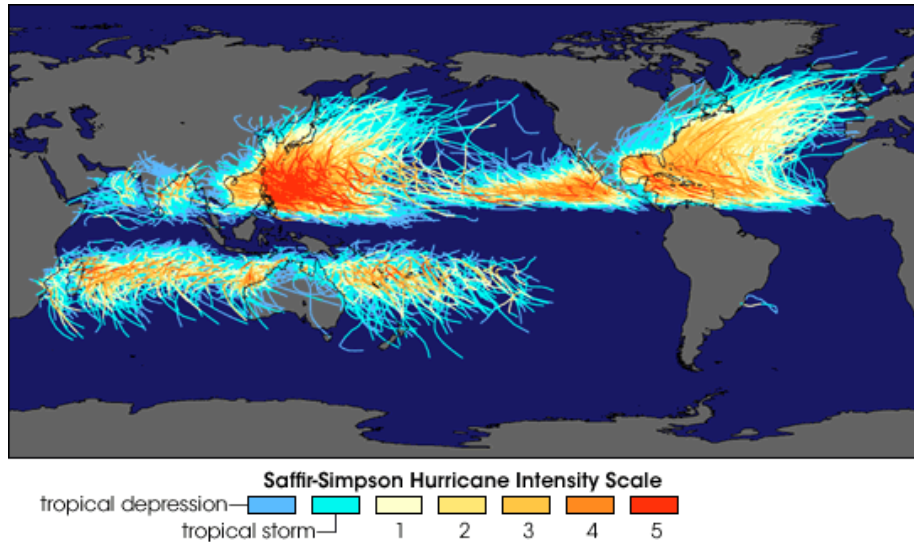
Worldwide Tracks of Tropical Cyclones Over the 150-Year Period Through 2006

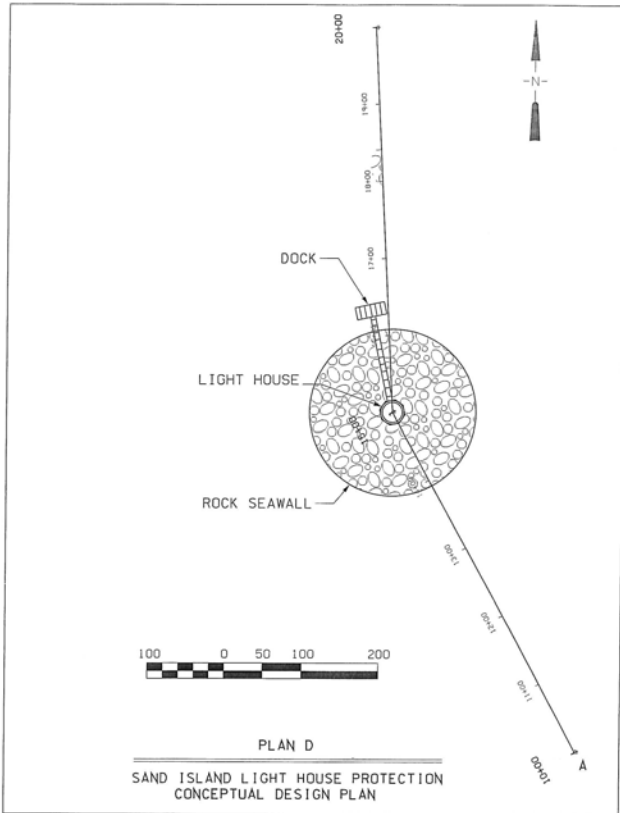
Additional Rock Protection for Island

If the primary goal is to protect the foundation of the lighthouse only, this could be accomplished by placing additional rock on the island without disturbing the existing rock blanket. While this approach would significantly strengthen the existing armor blanket covering the island, it would not provide an environment conducive to safely accommodating potential visitors to the lighthouse.

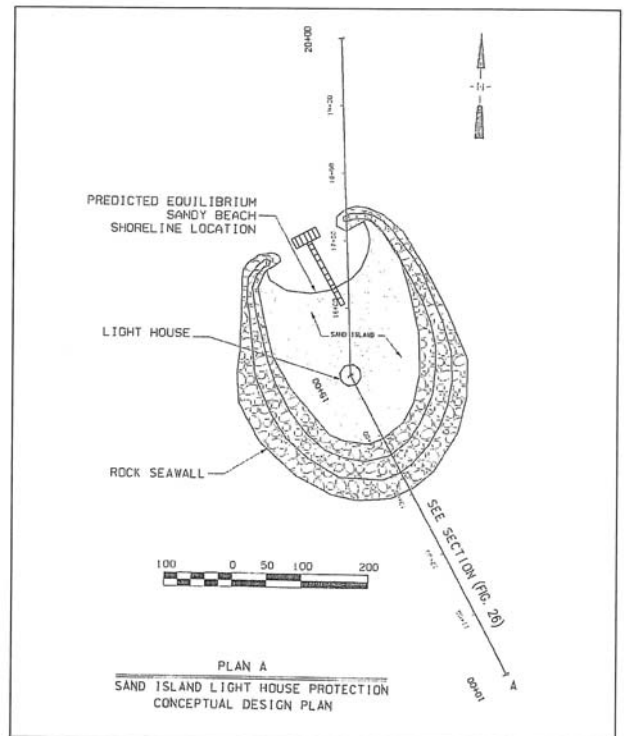
Enlarged Island

If a major goal of the restoration program is to provide an enlarged island that would encourage public use of the lighthouse, a 1.3-acre island having a sheltered sandy beach and a somewhat protected anchorage for visiting boats could be constructed. The shoreline of the island would be formed on three sides by a rubble-mound seawall made of rocks. The lower wave energy north-northwest facing side of the island would be left open to form a sandy beach to provide access to the island. If desired, a dock could be included across the sandy beach to further improve access. Following completion of the masonry and metal repairs, opportunities could be pursued to encourage public visitation of the lighthouse by constructing the dock and other amenities on the island.
